PRELIMINARY ASSESSMENT
OF
PROTO CIRCUITS INC.
ROCKVILLE, MARYLAND
(MD-399)

FEBRUARY, 1992

Prepared By: Maryland Department of the Environment
Hazardous and Solid Waste Management Administration
2500 Broening Highway
Baltimore, Maryland 21224

Prepared For: U.S. Environmental Protection Agency
Region III
841 Chestnut Building
Philadelphia, Pennsylvania 19107

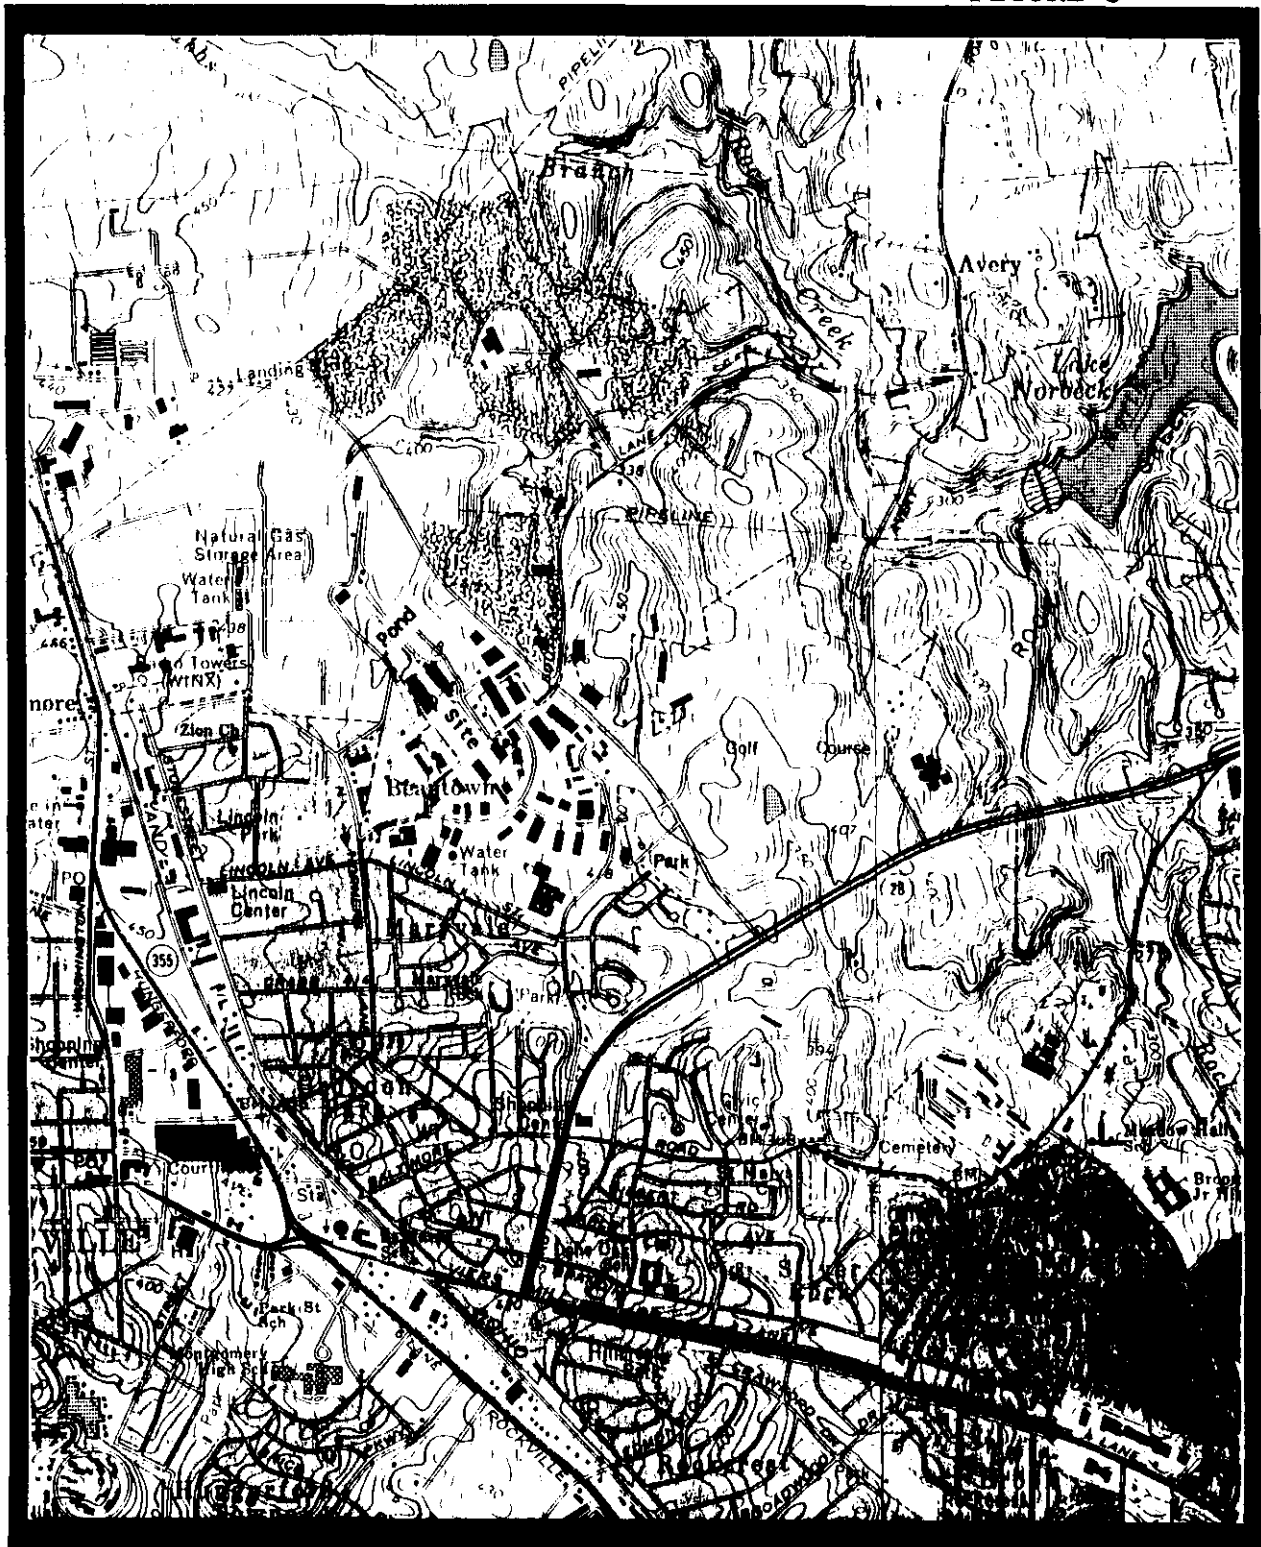
FIGURE 5

Within the Sykesville Formation local exposures of Basic igneous rocks occur in a north-south alignment, which may represent

the trace of a fault or major fracture zone (Figure 5). There is no Karst terrain within a four-mile radius of the site.

LOCAL TOPOGRAPHY AND SURFACE WATER

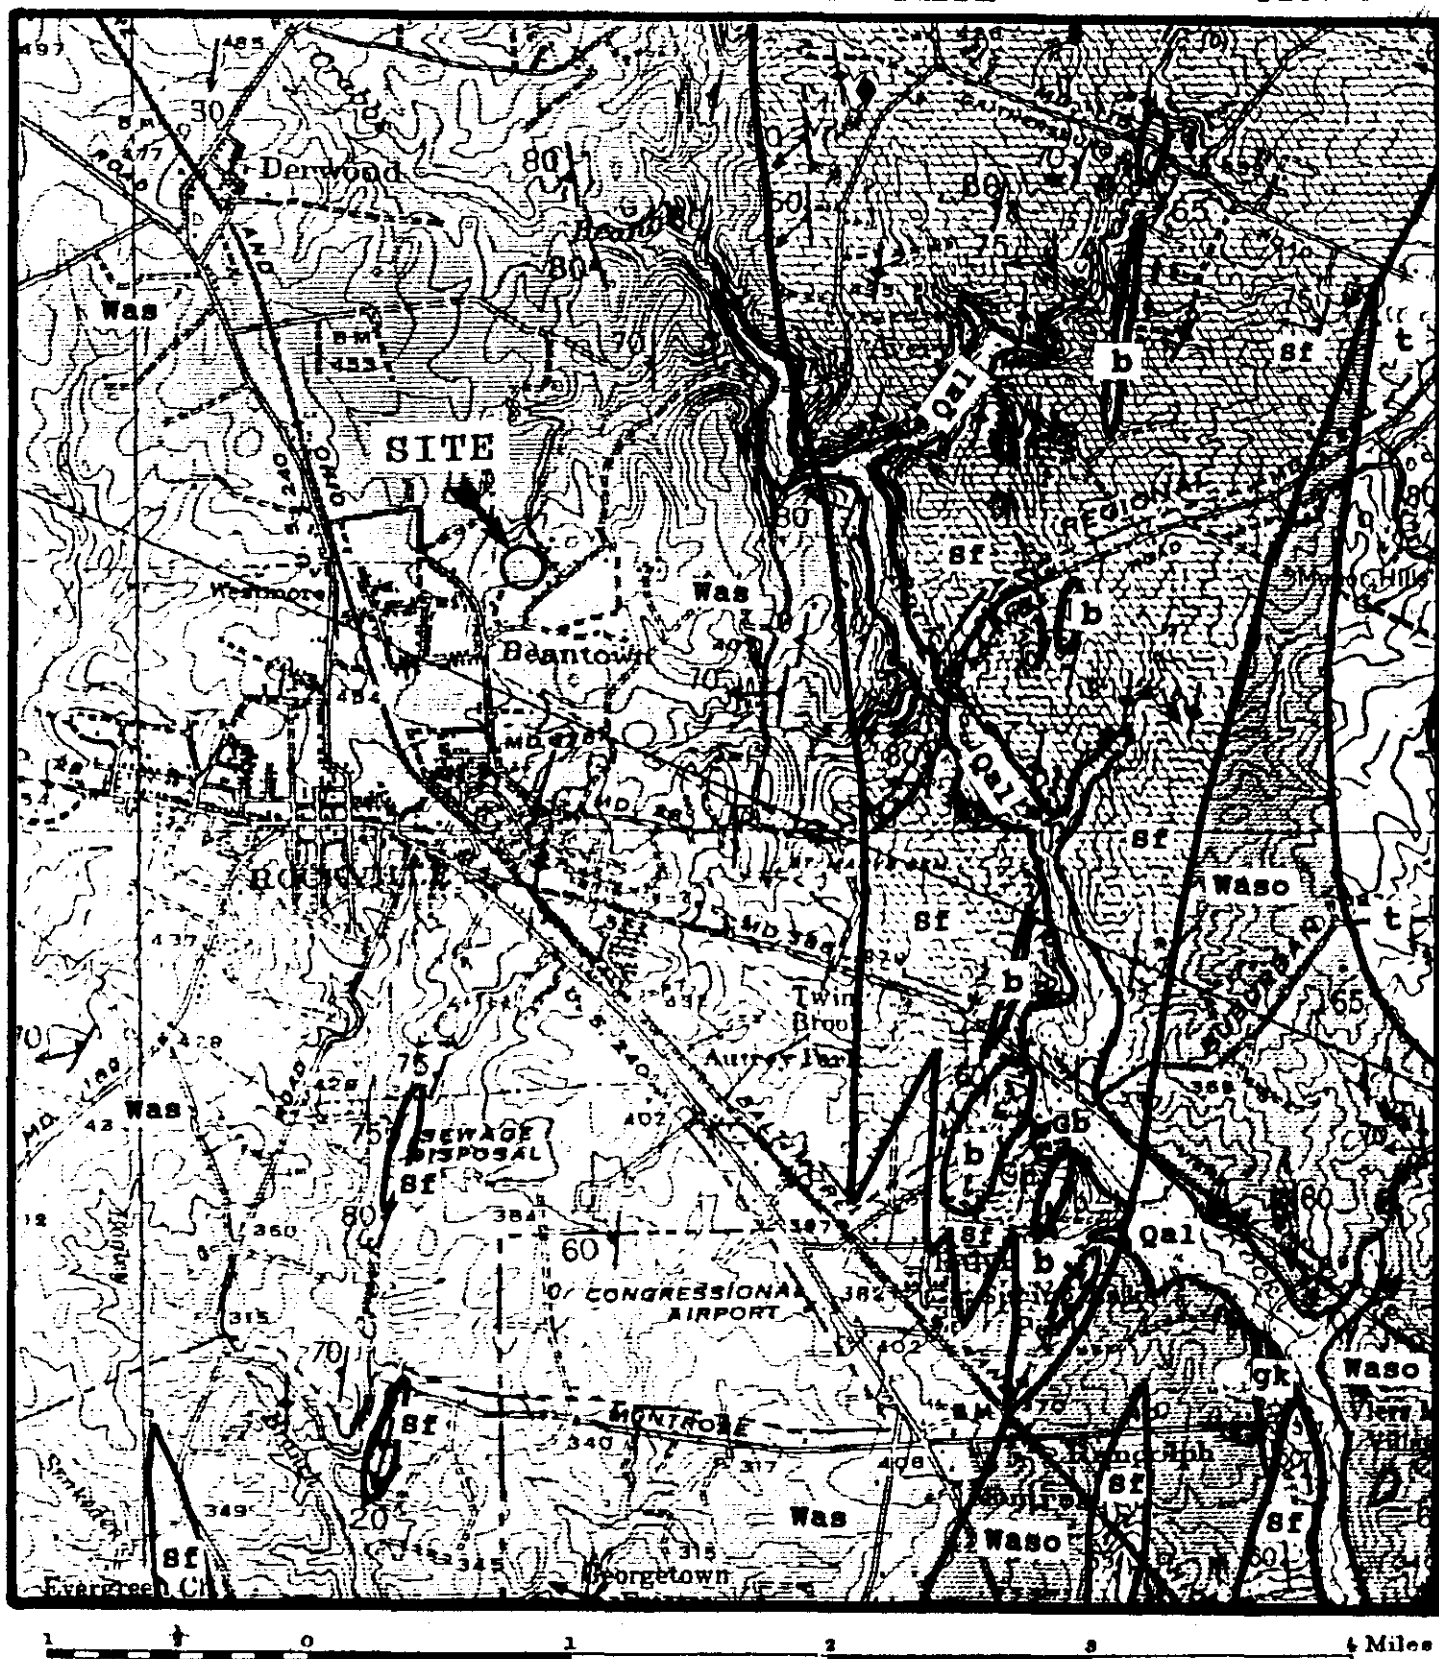
FIGURE 6

The contact between the Wissahickon and the Sykesville Formation occurs approximately one mile east of the site (Figure 6). The Sykesville Formation consists of poorly-foliated to massive, medium grained, biotite-plagioclase -quartz gneiss, which looks deceptively like granite in appearance. The gneiss contains numerous clasts ranging in size from granules to cobbles and some larger slabs. The clasts are composed of chloritized biotite schist, quartz pebbles and granules, and quartzofeldspathic rock fragments. This formation has been referred to as the Boulder Gneiss. The Sykesville Formation also contains an intensely foliated schist member which is finer-grained than the boulder gneiss. The schist member is locally devoid of clasts, commonly garnetiferous, and contains abundant muscovite.

GEOLOGIC MAP
